## Case Study of a Landslide in Thit Seint Gon Village, Myanmar

Wai Phyo Kyaw Naing, Aung Kyaw Moe & Kyaw Kyaw Oo

Department of Geological Survey and Mineral Exploration  
Ministry of Natural Resources and Environmental Conservation, Myanmar

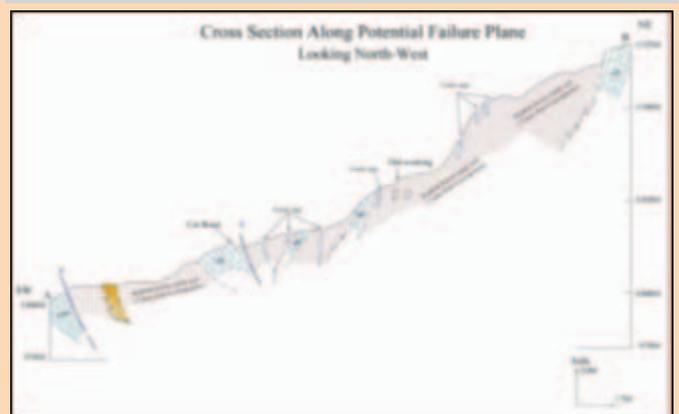
The direction of the initial cracks were NW-SE and about 15-20 cm in width. The apertures of initial cracks ranged from few mm to 10 cm. The occurrences were found continuously along NE-SW at most places and along NW-SE at some places (Figure 3). It was reported that water seeped out at four places near the roadway and buildings. The concrete floors of several houses in the village were damaged and the road was uplifted by about 20-30 cm by stress from the upper portion of the slope. No crack signs were found at the southern part of the road. All of the crack signs and damages occurred in the weathered leuco-granite rocks (Figure 4).

Figure 3: Cross section along the failure plane of the slope.

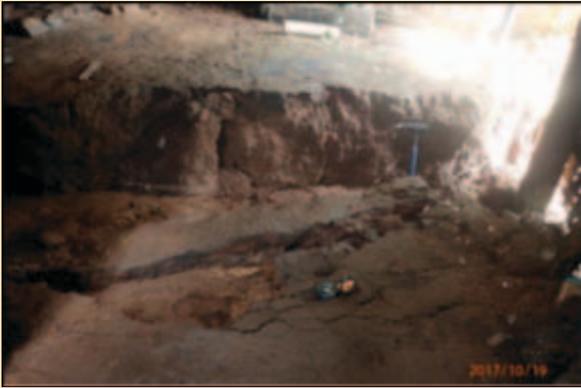
The rock units of the study area (300,000 m<sup>2</sup>) are made up of quartzite, calc-silicate rocks, marble, sandy soil, alluvium and leuco-granite (Figure 2). The weathered leuco-granite has low strength in engineering properties. Crack signs are common in the sandy soil of weathered leuco-granite.

Figure 4: Cracks in the weathered leuco-granite rocks.

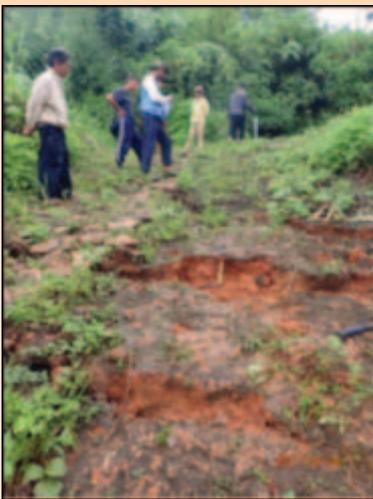
Figure 5: The sandy soil with sparse vegetation is susceptible to erosion.

The strength of the slope materials influence the magnitude and frequency of landslide and related events. The weathered leuco-granite was eroded by rainfall droplets and surface runoff. Considering the high porosity and permeability of the sandy leuco-granite, the soil moisture content and pore water pressure may have increased drastically. Increased pore water pressure from saturation reduces the strength of the slope materials. Many signs of initial cracks, water leakage from the toe of the slope and uplifting of the car road were observed in the area. Field investigation suggests that the landslide

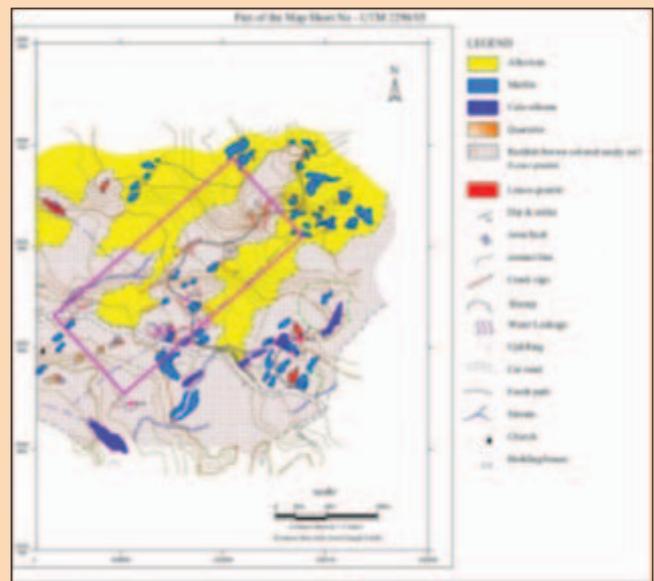
was complex; with land subsidence due to sinkholes, rotational movement of discontinuous debris, earth flow under steep slopes and poor cohesion. The identification of areas where landslide hazards may occur is the first step for mitigating landslides in Thit Seint Gon Village (Figure 6). Other recommendations include designing slopes or engineering structures to prevent and control the failure. Loading on the top of the slopes, placing fills on slopes, changing water conditions on slopes and cutting into sensitive slopes should be avoided.

Figure 6: Possible landslide hazardous zones in the Thit Seint Gon Village.

Drainage control is usually an effective way to stabilize a slope. Removal of unstable slope materials (grading), construction of retaining walls, control of surface and subsurface drainage or some combination of these could also be considered.
