# The Appearing Crack Signs and Uplifting of Car Road at the Popa Area, Mandalay Region & Brief Geohazard Event of Myanmar

Thet Zaw Nyein

Department of Geological Survey and Mineral Exploration MINISTRY OF NATRUAL RESOURCES AND ENVIRONMENTAL CONSERVATION MYANMAR

18<sup>th</sup> September 2018

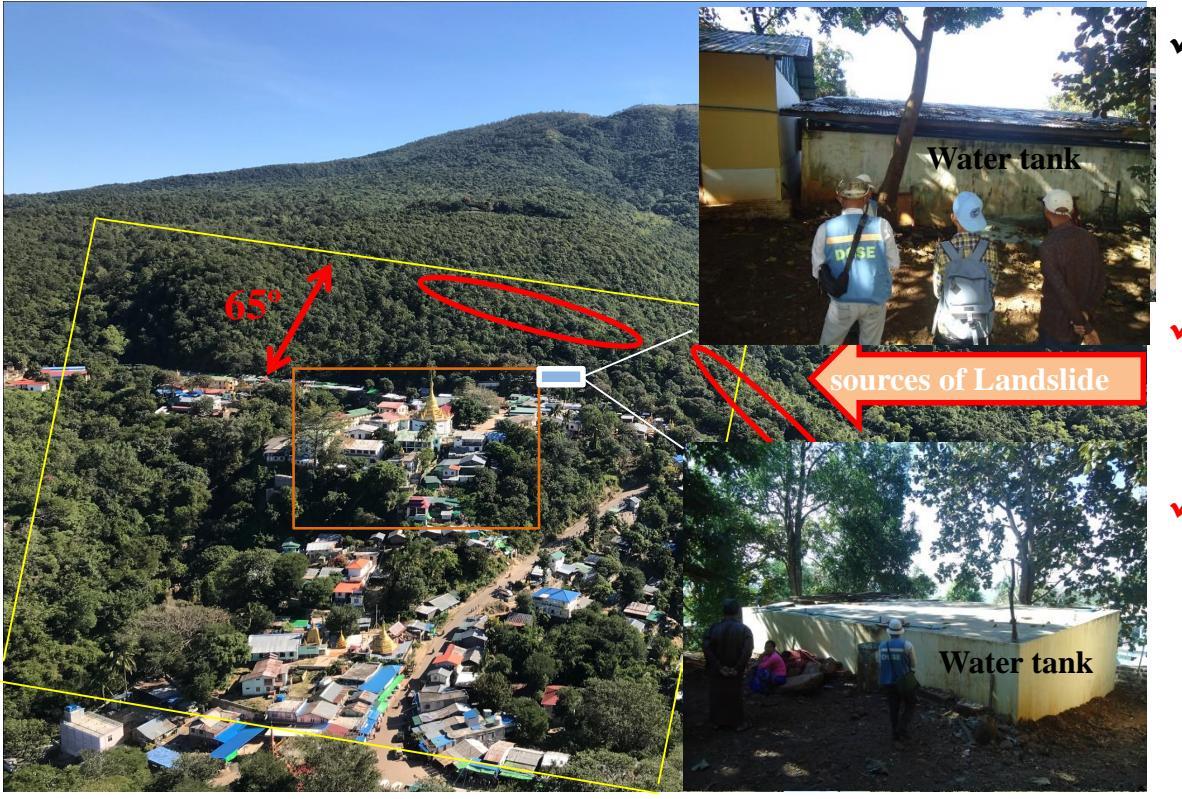
- The mountain is 750 m (above sea level) in height and the gradient of Slope >50°
- Over loading building and Heavy weight of Water tank
- ✓ Reactivation

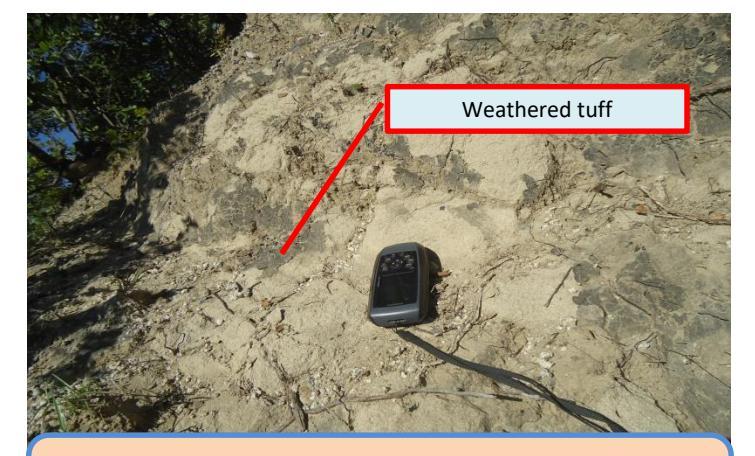
✓ Earth material on the slope is mainly composed of weathered tuff (Sandy soil).

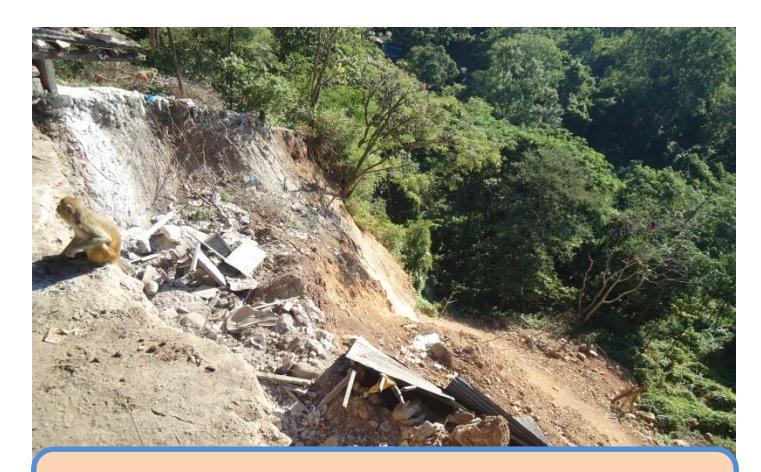
✓ Volcanic rock- tuff and agglomerate are poor cohesion

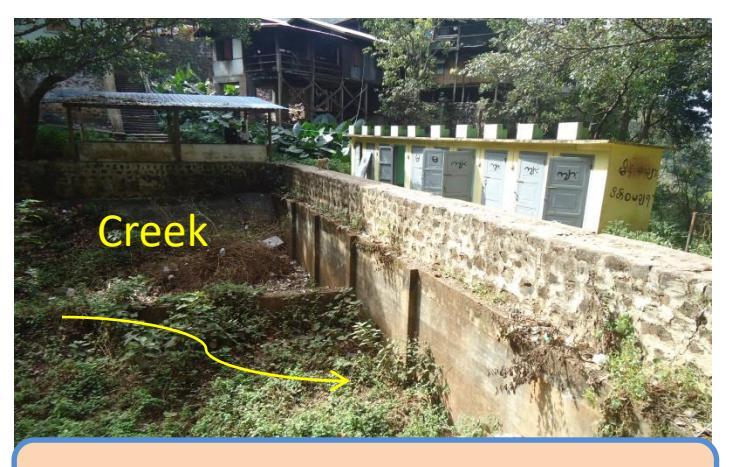
✓ Human Activities (build a small dam on a creek)

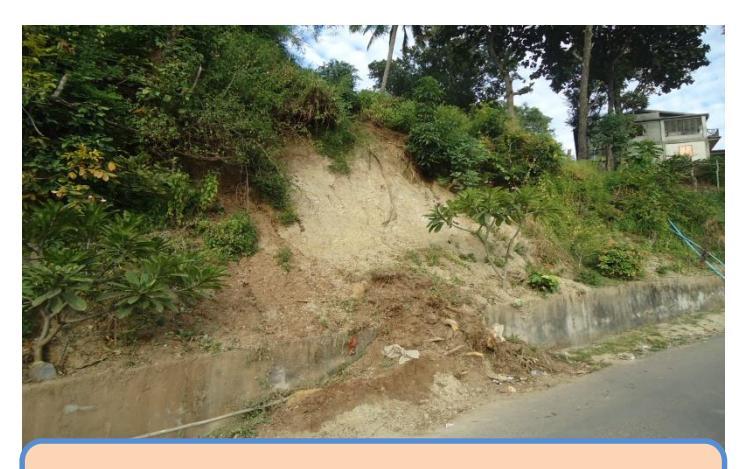
✓ Over saturated condition causes of Pore Water Pressure
