The Managing of Landslide in Local Area at
Tambon Nam Phai, Amphoe Nam Phad,
Uttaradit Province, Thailand.

Sitthinon Kultaksayos, Department of Mineral Resources, Thailand

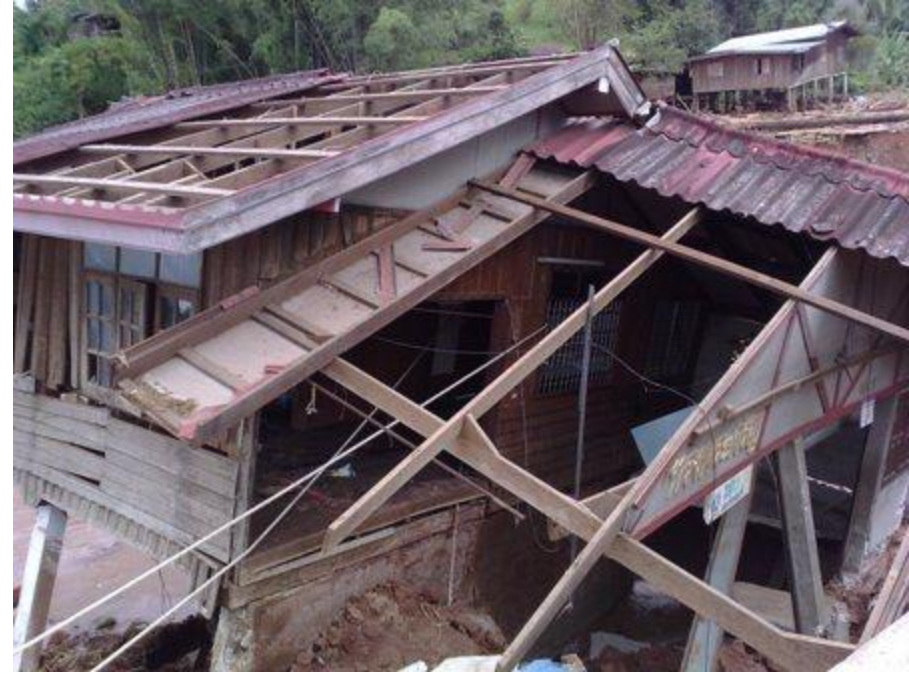
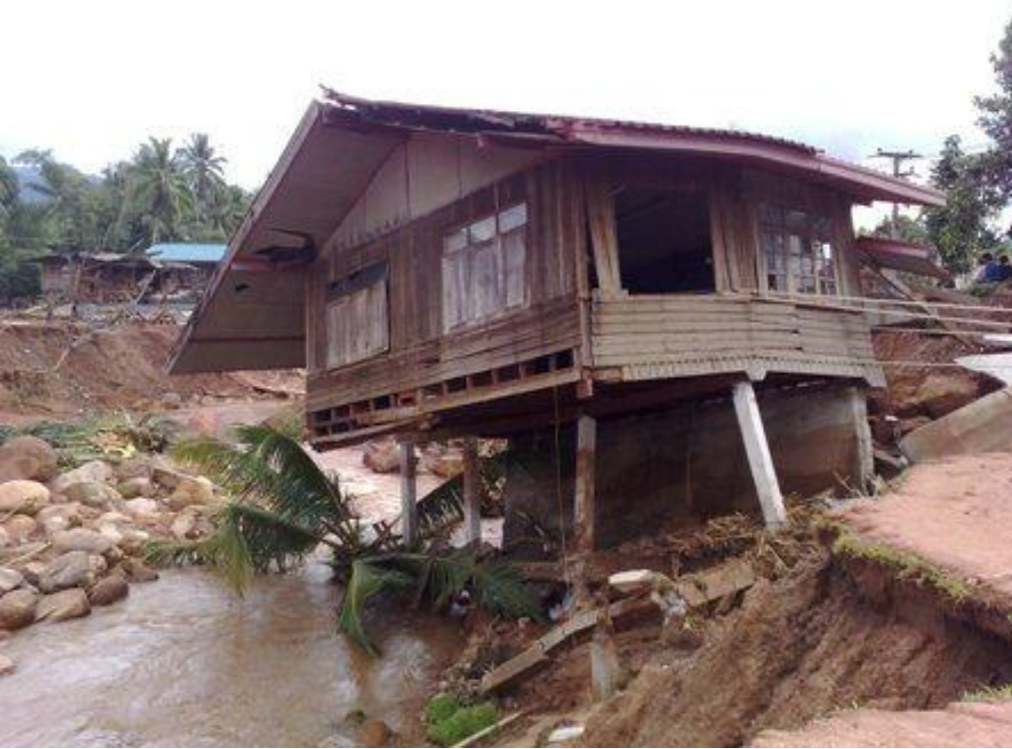
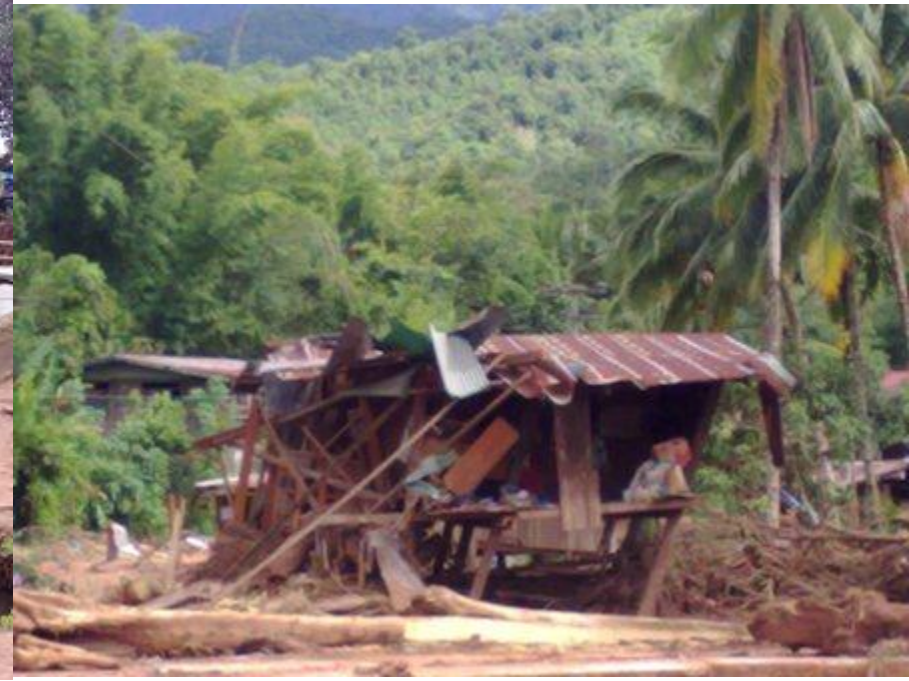
The large historic landslides in September 2011

- 6 people dead and one person is missing moreover 109 houses were both fully and partly destroyed
- About 6,720 sq.km. of farmland destroyed.
- The cost of damage caused is estimated at more than 1.6 million US dollars

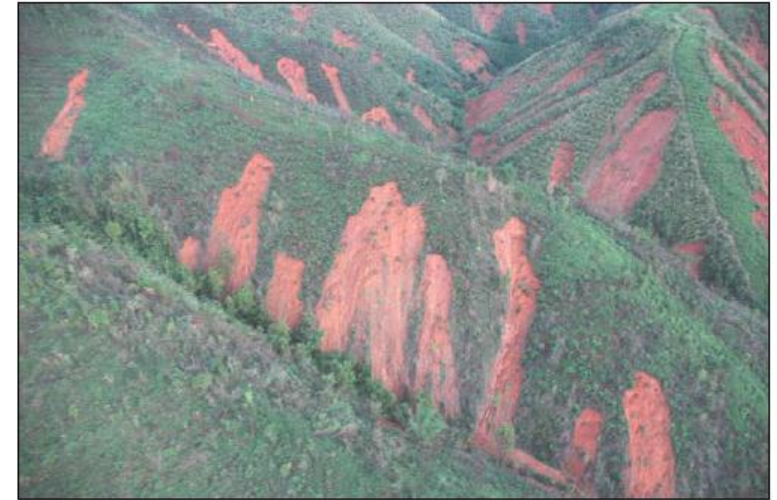
(3) Weathering

This area is in suture zone with densely a numerous of faults. The faults create cracks in rocks so it causes high-rate weathering.

Country boundary

Possible active fault

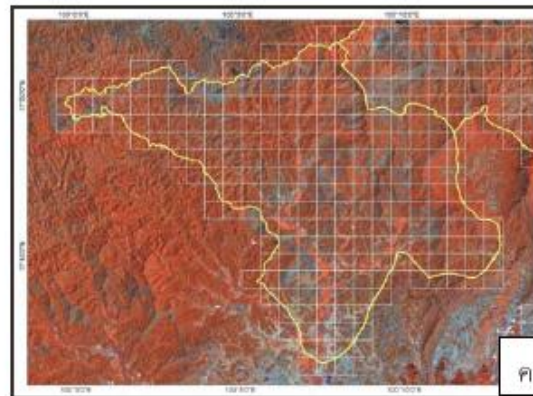
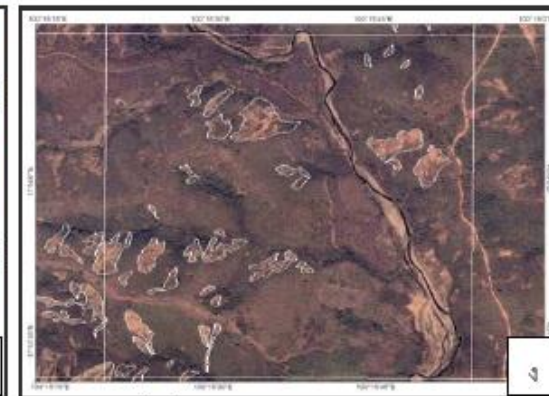
ก) เลือกใช้โปรแกรม ArcGIS 10.0

ค) แปลความหมายในแต่ละพื้นที่ 1 ตารางกิโลเมตร

ข) แบ่งพื้นที่เป้าหมายขนาด 1x1 กิโลเมตร

ง) กำหนดขอบเขตของดินถล่ม

หมายเหตุ : เป็นตัวอย่างพื้นที่ศึกษาบริเวณตำบลบ้านด่าน อำเภอเมือง จังหวัดอุตรดิตถ์

The traces of previous landslide data

Prepare fundamental data
(satellite image, topography map,
geological map, etc.)

Aerial photo and satellite image
(Spot 5, IKONOS, Google Earth)

landslide traces and risk area
interpretation from aerial photo
and satellite image

Locate traces and risk areas in
shape files

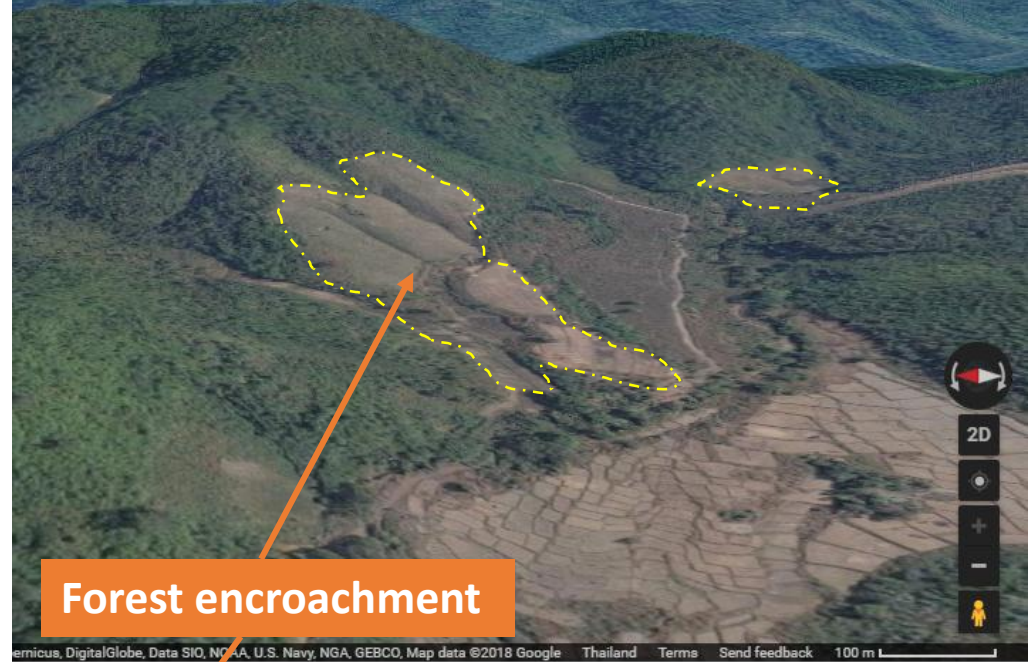
Forest encroachment

At mountain slope destroys coherence between surficial soil and basement rock, then soil can be slide.
