**Training Workshop on Disaster Resilient Cities:
Advances in Meteorological Forecasting and Hazards
Assessment**

**Precursor Phenomena of Landslide
in Thit Seint Gon, Vicinity of Mogok
(Gemstone Tract)**

7. Thit Seint Gon Landslide

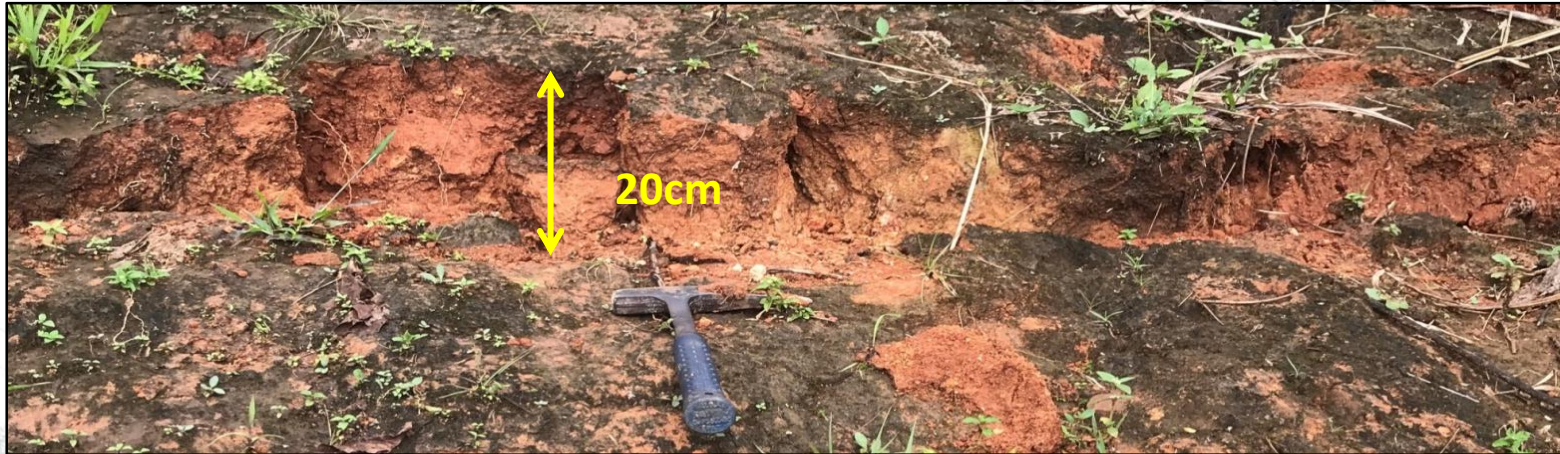
Many crack signs appeared and the car road was uplifted owing to creep the soil after the continuous heavy rains.

- **This Seint Gon Village which occurred landslide is situated in **Mogok Township (Gemstone Tract), Myanmar.****
- **The population is very thin and mostly **Lisu** race are living.**
- **During September, 2017 the vicinity of This Seint Gon was appeared the initial crack signs and uplifting the car road.**
- **Our field group was assigned by **Ministry of Natural Resources and Environmental Conservation**, Myanmar. Then our field group carried out the field investigation from 17th October to 23th October, 2017.**

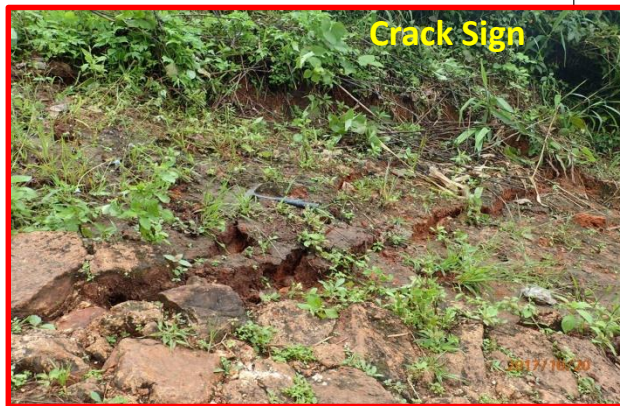
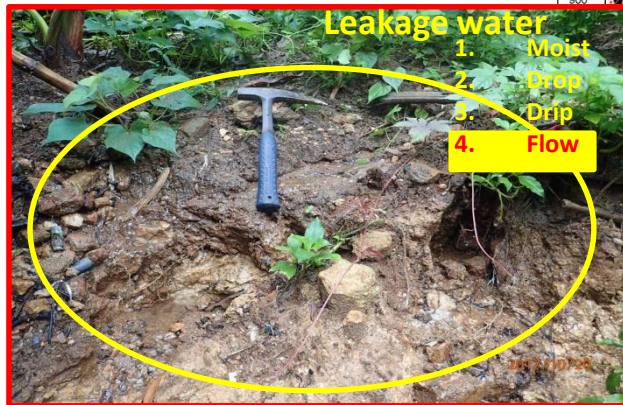
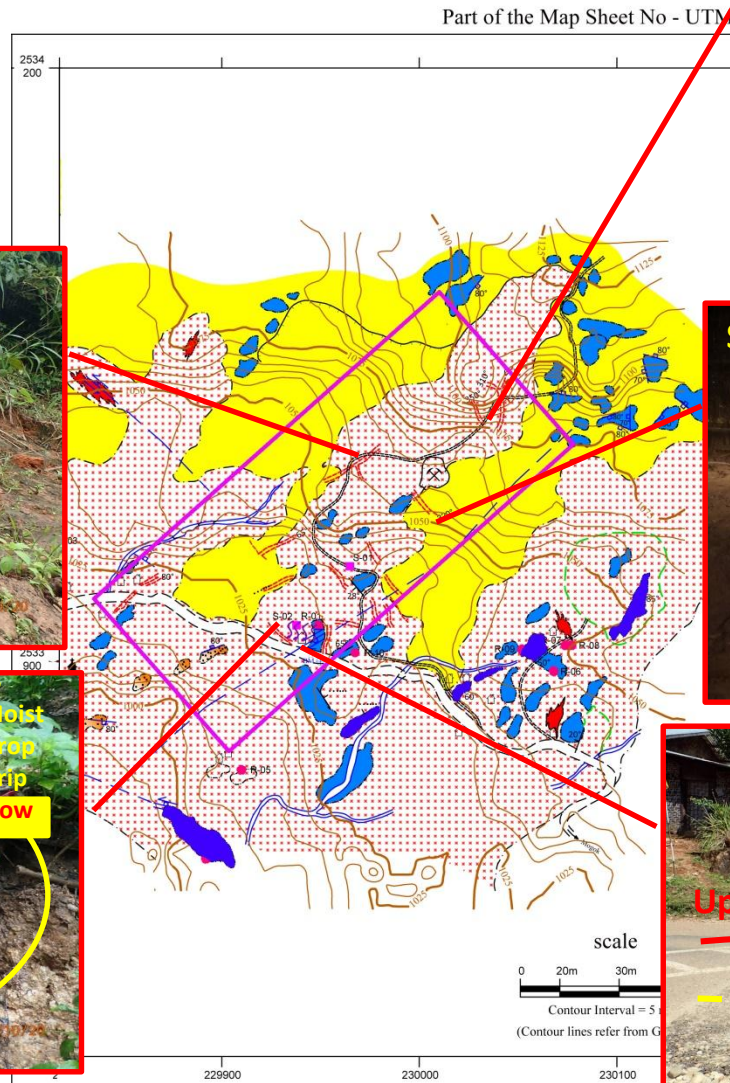
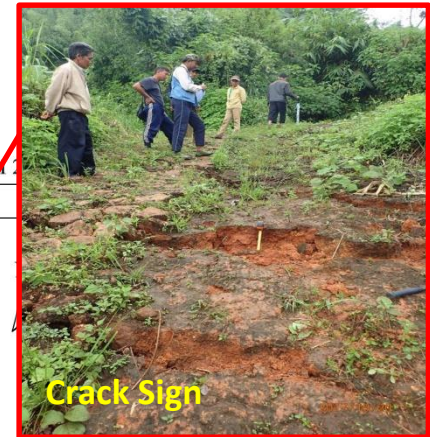
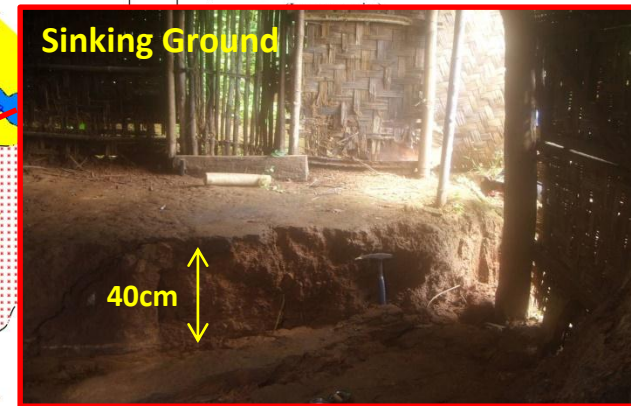
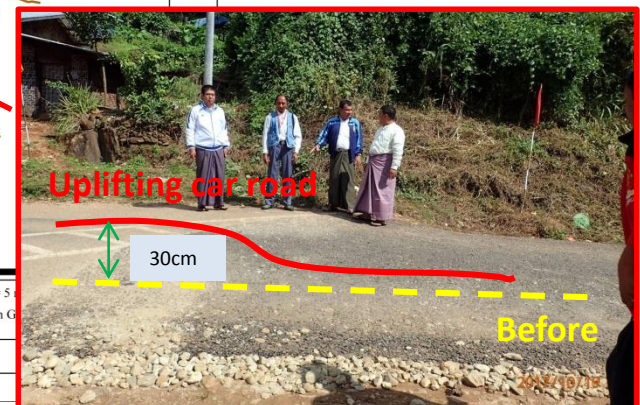
1:1000 scale detailed mapping of Thit Seint Gon Area.

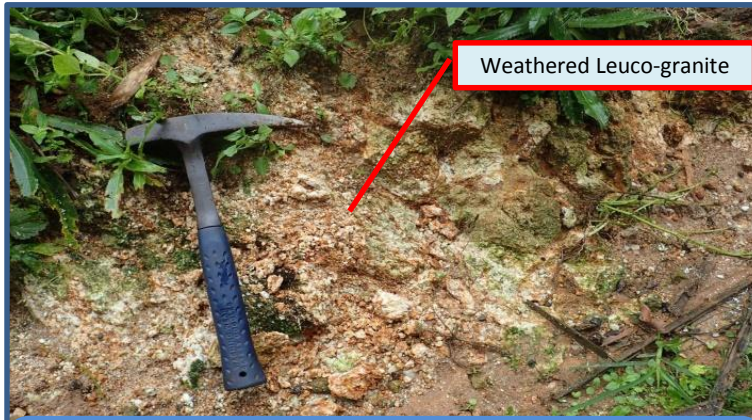
Weathered Leuco-granite

4. Earth material on the slope is mainly composed of weathered leuco-granite (Sandy soil).

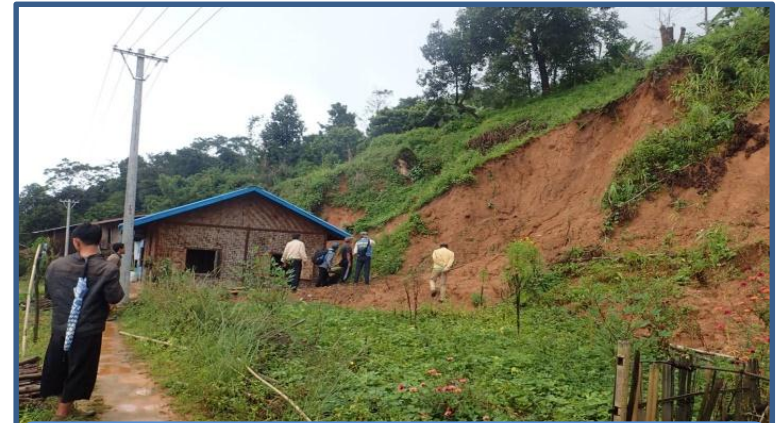
5. Poor Drainage System (Increasing Pore Water Pressure)

Mitigation of Landslide – Need to carry out the drainage system of surface and underground, reinforced earth wall and planting with the guide of a geotechnical engineer.

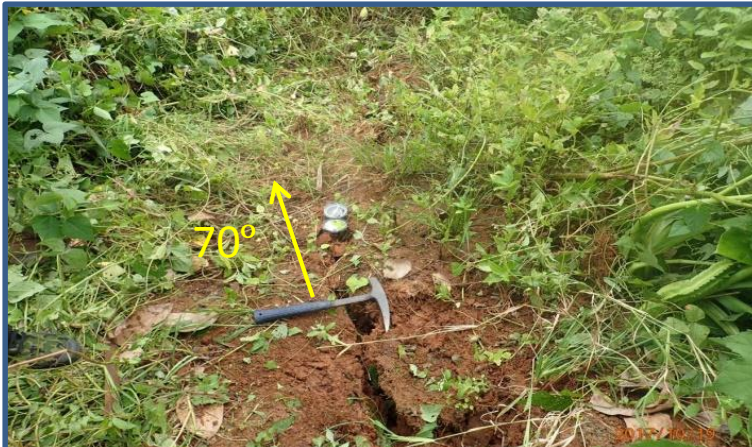
6. Local fault and direction of crack signs. (Generally = 70°)

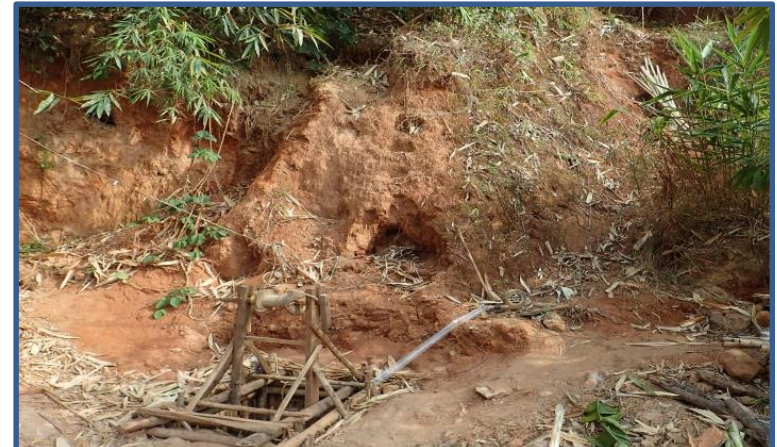
7. Human Activities (Old pit of Gemstone Mining activities)
