GEOLOGICAL INVESTIGATION OF RIVER TERRACES AND ASSESSMENT OF SINKHOLE HAZARD IN THE ARMALA AREA, POKHARA, NEPAL

Sabin Sharma*, Rama Mohan Pokhrel, and Lalu P. Paudel

Department of mines and environment, Hetauda Cement Industries Limited, Nepal

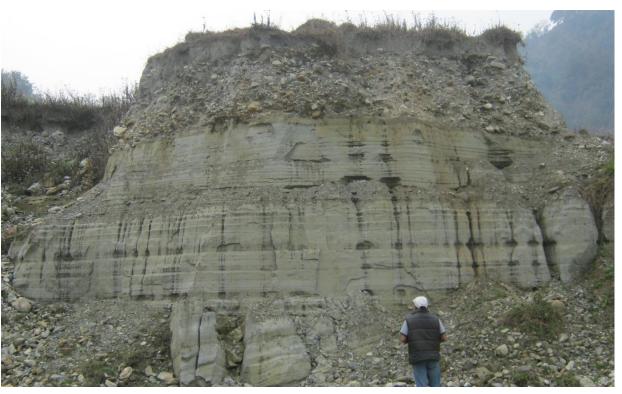
Sinkhole hazard area: Phewa Formation

Lithology: fluviolacustrine deposit of gray color calcareous clayey silt and gravel deposit

Other formations observed in the study area.
Image shows different formations seen in the Seti river terraces

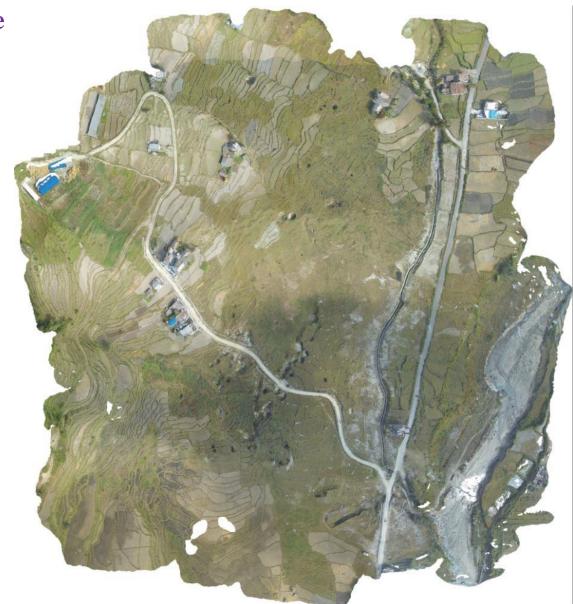
Preparation of Sinkhole inventory map:

1. Image of sinkhole area obtained by drone camera.

2. Google Earth Satellite images taken in different years were observed to know the history of sinkhole and its changing pattern in the Armala area.

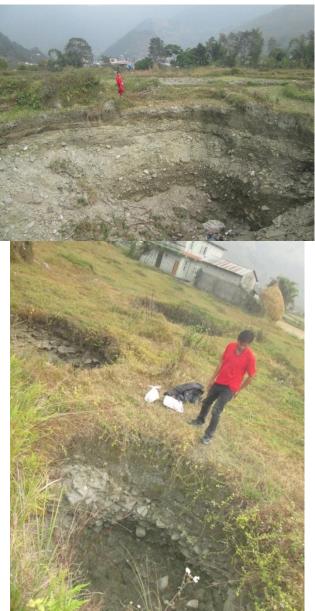
Possible Causes of Sinkhole Formation
