# The Appearing Crack Signs and Uplifting of Car Road at the Popa Area, Mandalay Region & Brief Geohazard Event of Myanmar

Thet Zaw Nyein

Department of Geological Survey and Mineral Exploration MINISTRY OF NATRUAL RESOURCES AND ENVIRONMENTAL CONSERVATION MYANMAR

18<sup>th</sup> September 2018

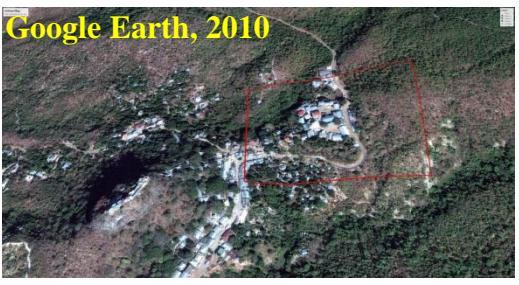
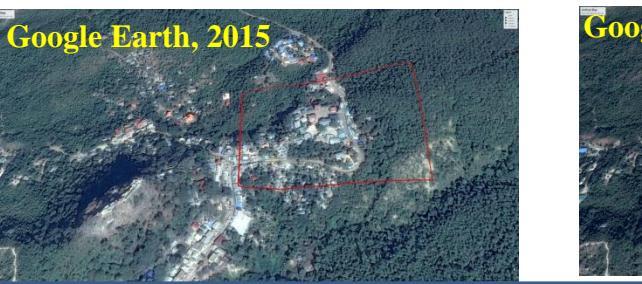
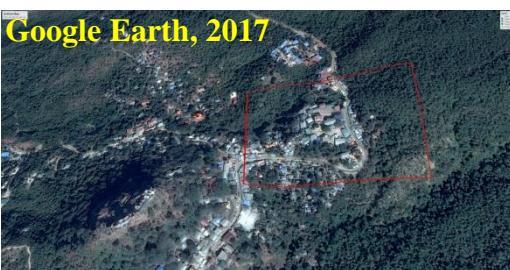
- The mountain is 750 m (above sea level) in height and the gradient of Slope >50°
- Over loading building and Heavy weight of Water tank
- ✓ Reactivation
