## Case Study of a Landslide in Thit Seint Gon Village, Myanmar

Wai Phyo Kyaw Naing, Aung Kyaw Moe & Kyaw Kyaw Oo

Department of Geological Survey and Mineral Exploration  
Ministry of Natural Resources and Environmental Conservation, Myanmar

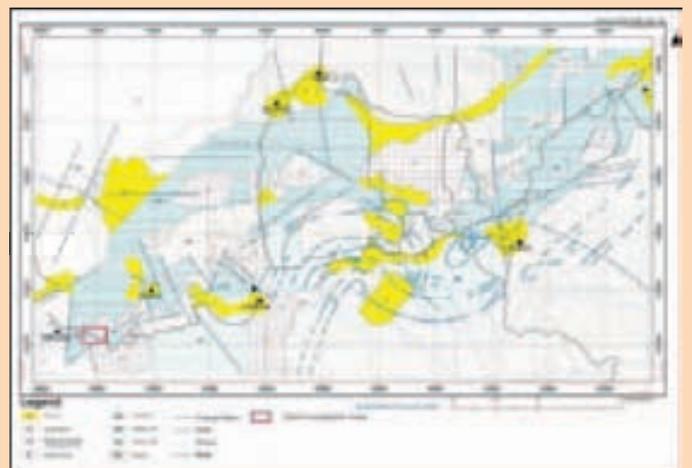
The rock units of the study area (300,000 m<sup>2</sup>) are made up of quartzite, calc-silicate rocks, marble, sandy soil, alluvium and leuco-granite (Figure 2). The weathered leuco-granite has low strength in engineering properties. Crack signs are common in the sandy soil of weathered leuco-granite.

Figure 2: Geology of the Thit Seint Gon Village.
